TECHNICAL REPORT

**OGV CLEAN FUEL REGULATION INVESTIGATION OF
OPERATIONAL ISSUES PRELIMINARY FINDINGS**

ARB CONTRACT No. 09-410

**Robert K. Jackson
Engineering Technology Department
rjackson@csum.edu**

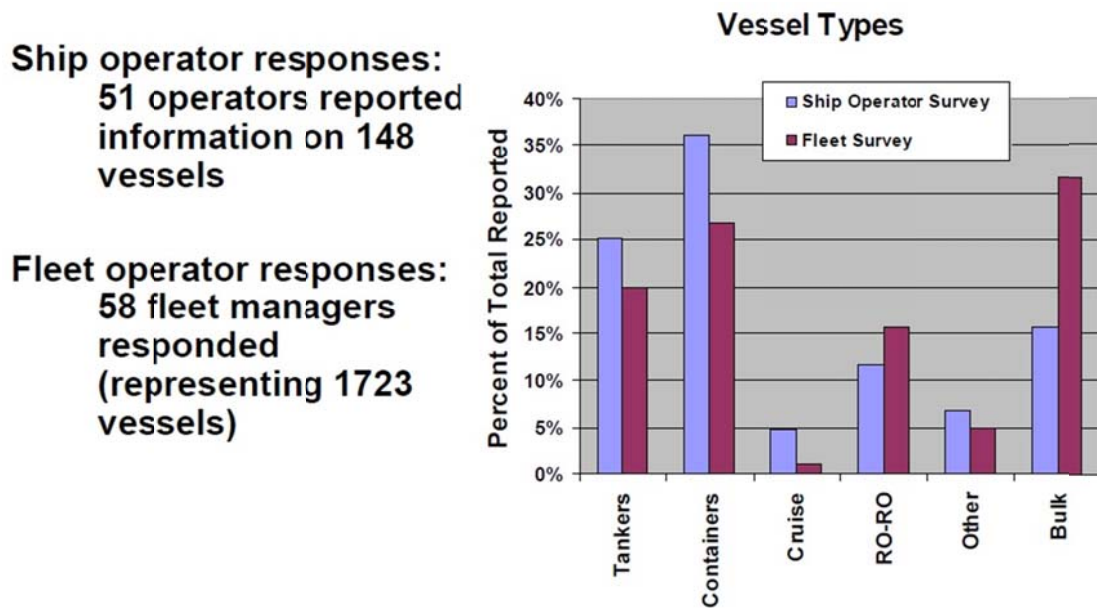
Figure 2.2-1: Number of OGV Survey Participants and Vessel Types

The survey was sent to the ARB listserve which is comprised of 2400 members. A total of 58 fleet managers responded to the survey, providing information on the fleets that they manage and 51 individual vessel operators responded. Figure 2.2-1 gives an overview of the survey responses and the vessel types which were included in the survey. Additional information on the survey and survey results can be found at:

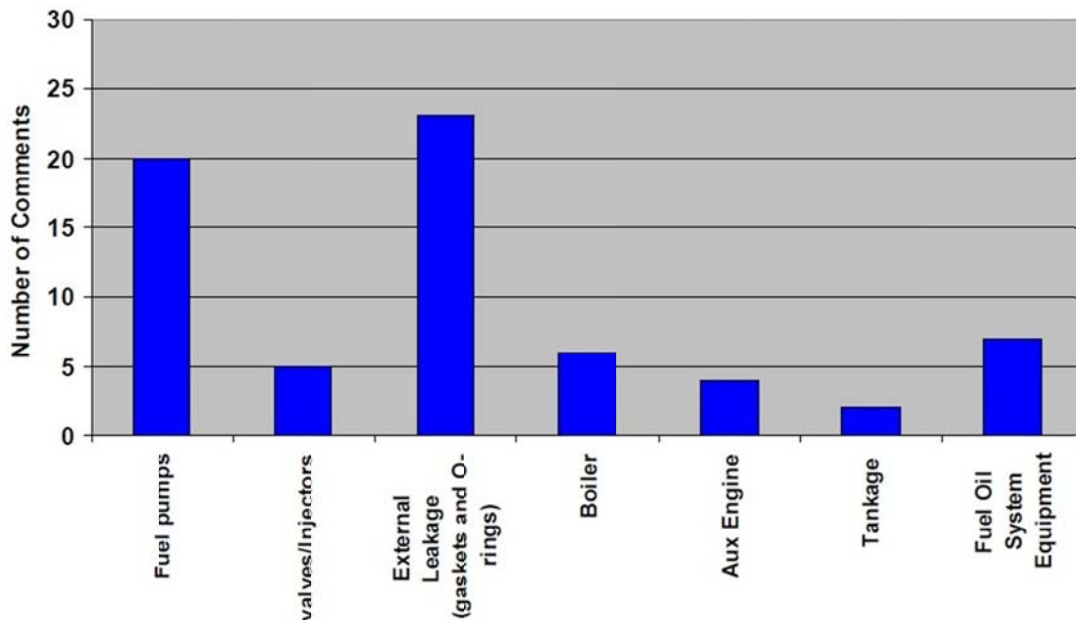
Figure 2.2-2: OGV Survey Reported Equipment Problems

***This information was compiled by categorizing the survey comment fields**

The fuel switching operational problems reported in the ARB Survey were primarily noted as occurring after switching from heavy fuel oil to distillate (see Figure 2.2-2 below) and a higher number of problems were noted during maneuvering as compared to transiting. Equipment problems were noted across a variety of equipment with the highest number of problems focusing on equipment leaks and with fuel pumps as shown in Figure 2.2-2.

Excessive fuel leakage due to the low viscosity of distillate fuel can be a significant problem that can affect vessel operation (Figure 2.2-2). Excessive fuel leakage from fuel system gaskets and seals, circulating pump shaft seals, high-pressure fuel pumps, and fuel valves has been reported. Internal leakage through high-pressure fuel pumps and fuel valves can result in an excessive amount of fuel returning back to the fuel drain tank.

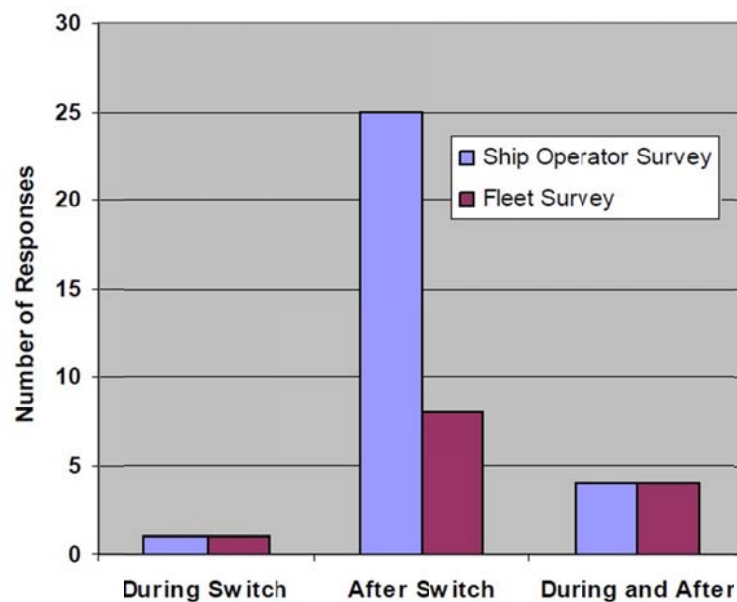
Figure 2.2-3: OGV Survey Timing of Problems Due to Fuel Switching

Figure 2.2-3 illustrates the responses to an OGV Survey question “If you had problems, did the problems occur during fuel switching, after fuel switching or both?” Vessel operators reported that more difficulties occurred after fuel switching than the time period during which the fuel switching was taking place.

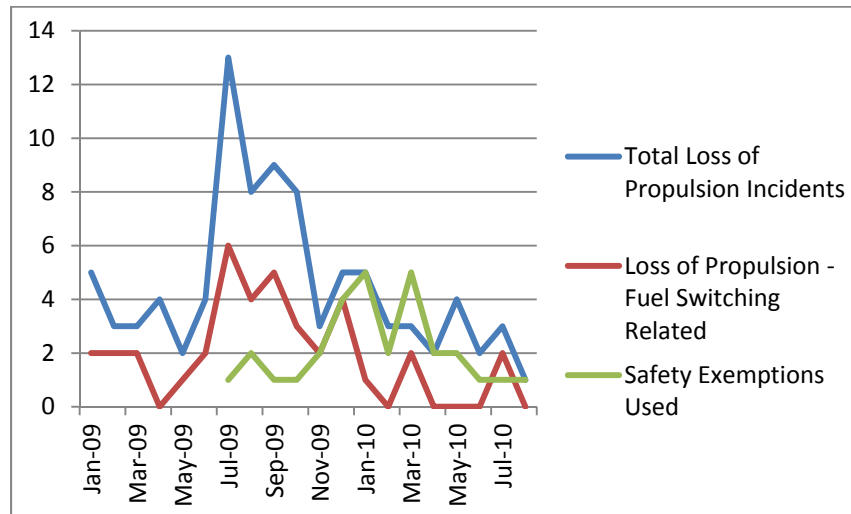
Figure 2.3-1: Comparison of Various Loss of Propulsion Incident Types

Table 2.3-1 and Figure 2.3-1 also provides data on the frequency that which ocean-going vessel operators used the Safety Exemption. The California ARB ship fuel regulation contains a Safety Exemption, which allows the vessel master to use HFO if that person determines that compliance would endanger the safety of the vessel, its crew, its cargo, or its passengers because of severe weather conditions, equipment failure, fuel contamination, or other extraordinary reasons beyond the master’s reasonable control. A number of vessel masters have utilized this provision to allow the engineering staff time to make necessary repairs to the main engine or fuel system.

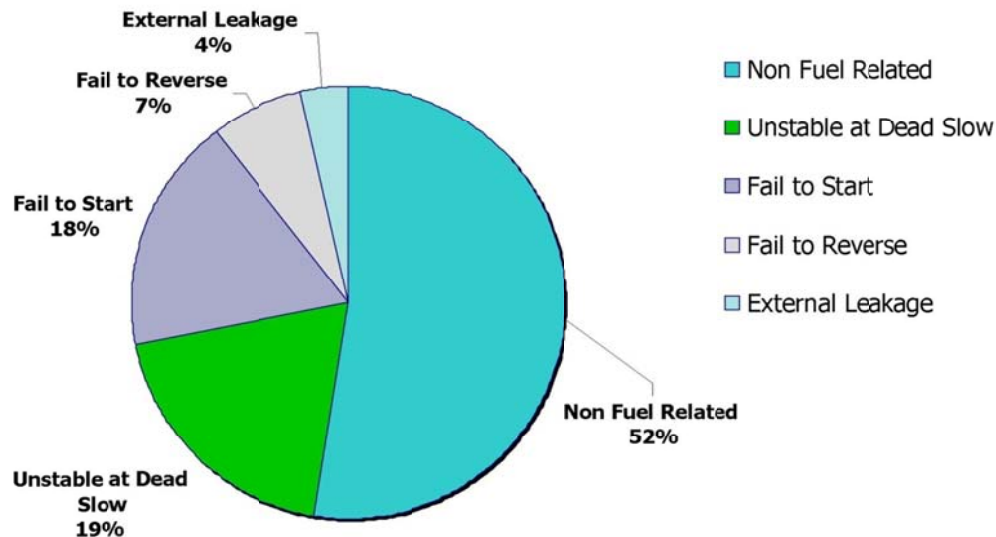
Figure 2.3-2: Breakdown of LOP Incidents.

(Data obtained from information contained within USCG Incident Reports)
Source: USCG [Reference 1]

It should be noted that over half of all the reported LOP incidents were not listed as fuel switching related, as seen in Figure 2.3-2 below. While there have been some vessels which have had difficulty operating on distillate fuel, LOP incidents are currently at pre-regulation levels. With about 10,000 vessel visits between July 1, 2009 and July 31, 2010 the vast majority are successfully operating on distillate fuel. However, continued operational difficulties remain a concern and this report provides an initial evaluation of the root causes of LOP incidents.

CMA Technical Staff reviewed the LOP incident reports that were denoted by the USCG as being fuel switching related and identified the primary operational issue that resulted in the LOP. As shown in Figure 2.3-2, the primary operational issues noted were: the main propulsion engine was unstable at low loads, the main engine failed to start, excessive fuel leakage, and failure to reverse. It is the opinion of CMA Technical Staff that the LOP incidents are primarily related to: 1) fuel viscosity management, 2) maintenance procedures, 3) crew training, and 4) fuel system equipment condition. Below, CMA Technical Staff discuss the four operational issues most commonly reported in the LOP Fuel Switching Related reports reviewed as part of this investigation.

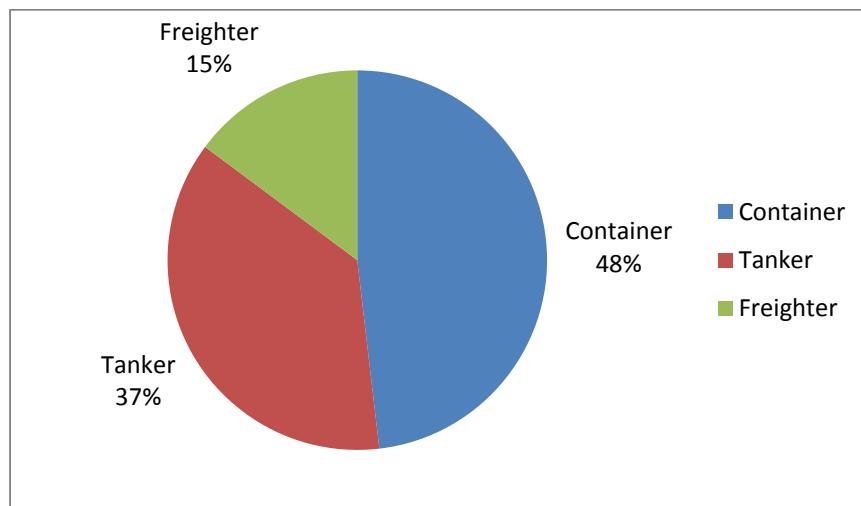
Figure 2.3-3: Vessel Types Involved in Fuel Switching Related LOP Incidents from 7/1/09 through 9/2/10

To date all of the vessels reporting a loss of propulsion have utilized the 2-stroke cycle slow-speed crosshead type diesel engine for propulsion. Figure 2.3-3 illustrates the different types of vessels which encountered Fuel Switching Related LOP incidents.

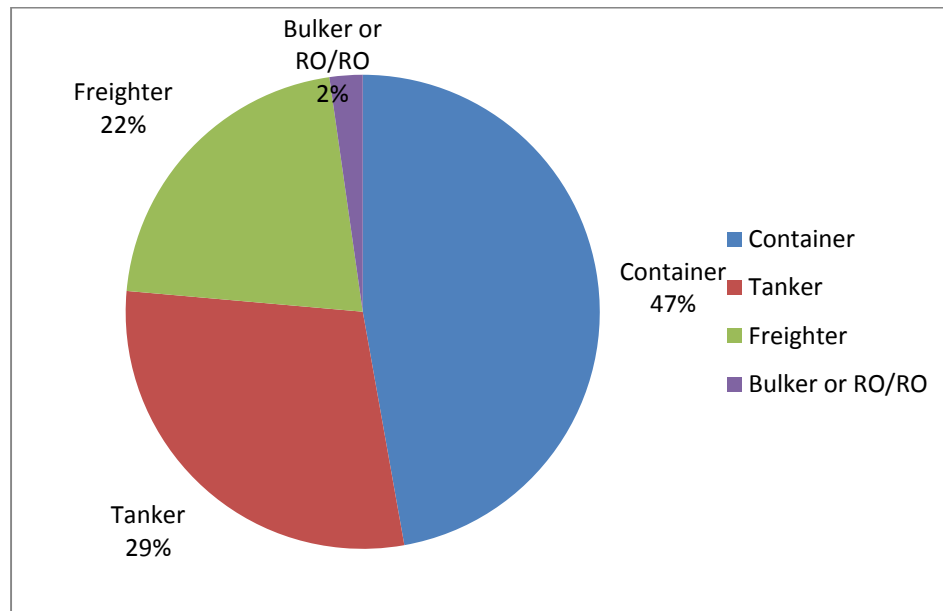
Figure 2.3-4: Vessel types Involved in LOP Incidents from 1/1/09 through 9/2/10

Figure 2.3-4 is a breakdown of all LOP incidents regardless of cause. A comparison of the engine bore size for fuel switching related LOP incidents is given in Figure 2.3-5. While engines with bore sizes between 600 & 700 mm have the highest percentage of incidents, this may be due to the popularity of this engine size.

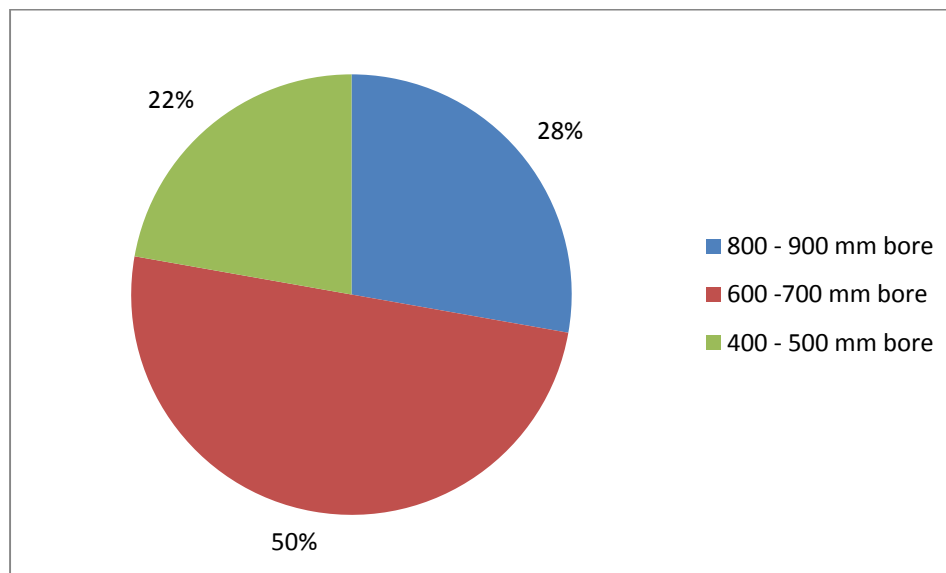
Figure 2.3-5: Fuel Switching Related LOPs Referenced by Cylinder Bore Size

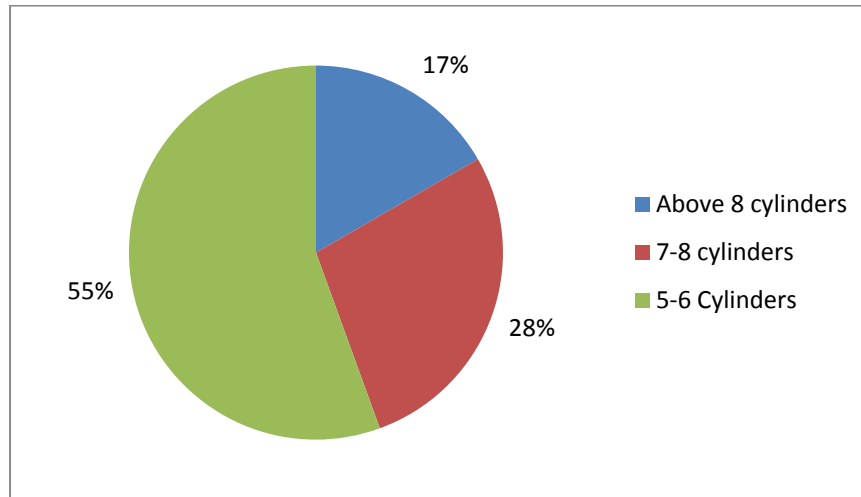
Figure 2.3-6: Fuel Switching Related LOPs Referenced by Number of Engine Cylinders

The fact that engines with fewer than seven cylinders have the largest percentage of fuel switching related LOP's as shown in Figure 2.3-6 may be more than purely statistical. The more cylinders that an engine has the less it would be affected by poor combustion in one of those cylinders.

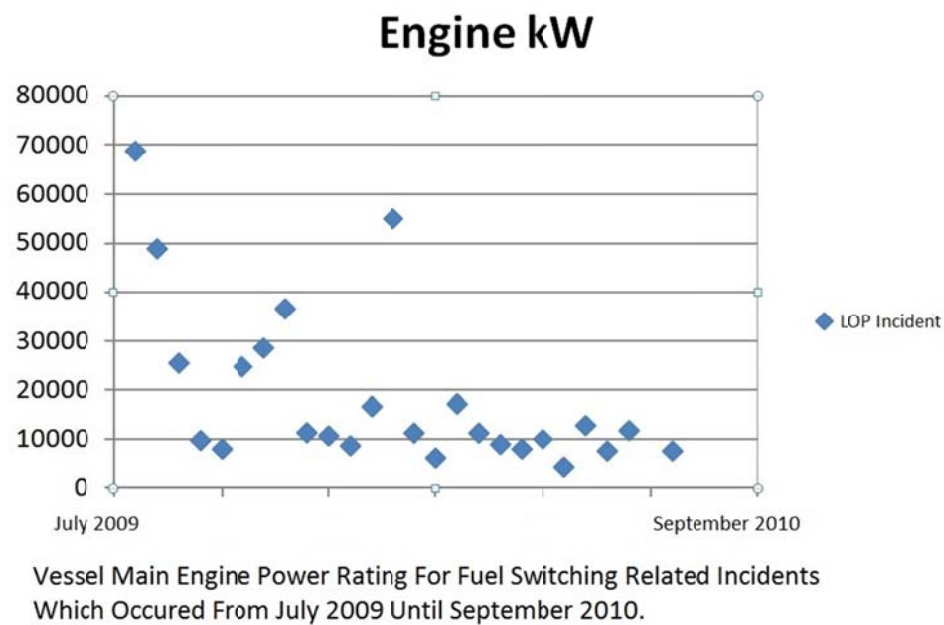
Figure 2.3-7: Fuel Switching Related LOPs Referenced by Propulsion Power Output

Figure 2.3-7 lists the propulsion power of those vessels which experienced fuel switching related LOP incidents. After carefully considering all the data provided concerning the different 2-stroke cycle diesel engines which experienced fuel switching related LOP incidents, we did not have sufficient information on vessel population to determine if there is a trend or if the data simply reflects the percentage of engines in the fleet visiting California.

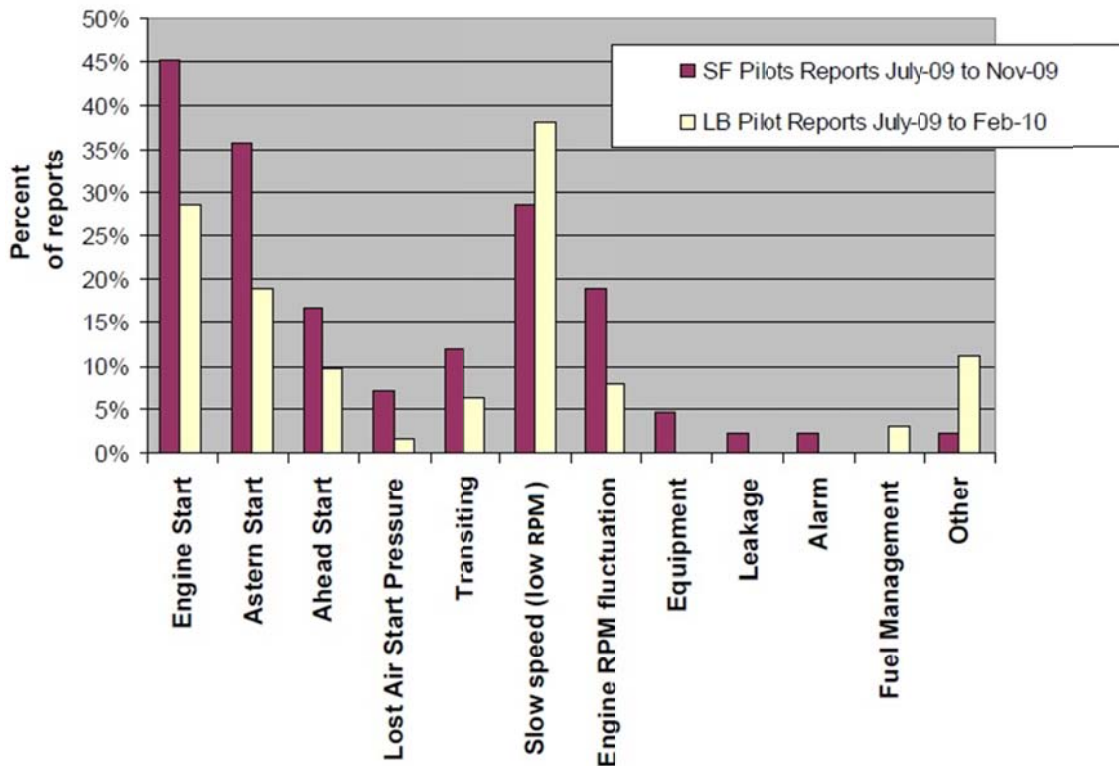
Figure 2.4-1: Breakdown of OGV Incidents Reported by SF Bar & LB Pilots

***Based on 42 SF Bar Pilot reports and 63 LB Pilot reports**

From July 2009 through December 2009, the San Francisco Bar Pilots and the Long Beach Bar Pilots maintained logs of any operational issues that they noted while piloting a vessel. The types of operational issues were grouped into 12 categories as shown in Figure 2.4-1 below. The operational problems reported show similar patterns to the USCG LOP incident reports. However, problems noted in the pilot logs did not always lead to an LOP incident.

As is shown, the vast majority of the operational incidents reported instability of the engine at low RPM (Dead Slow) or failure to start while running on distillate fuel. In addition, some vessels have reported difficulty starting the main engine in the astern direction while the vessel is moving through the water above a certain speed. The CMA Technical Staff believes the root cause for all three of these problems was poor combustion at low loads caused by low injection pressures and/or improper injection timing.

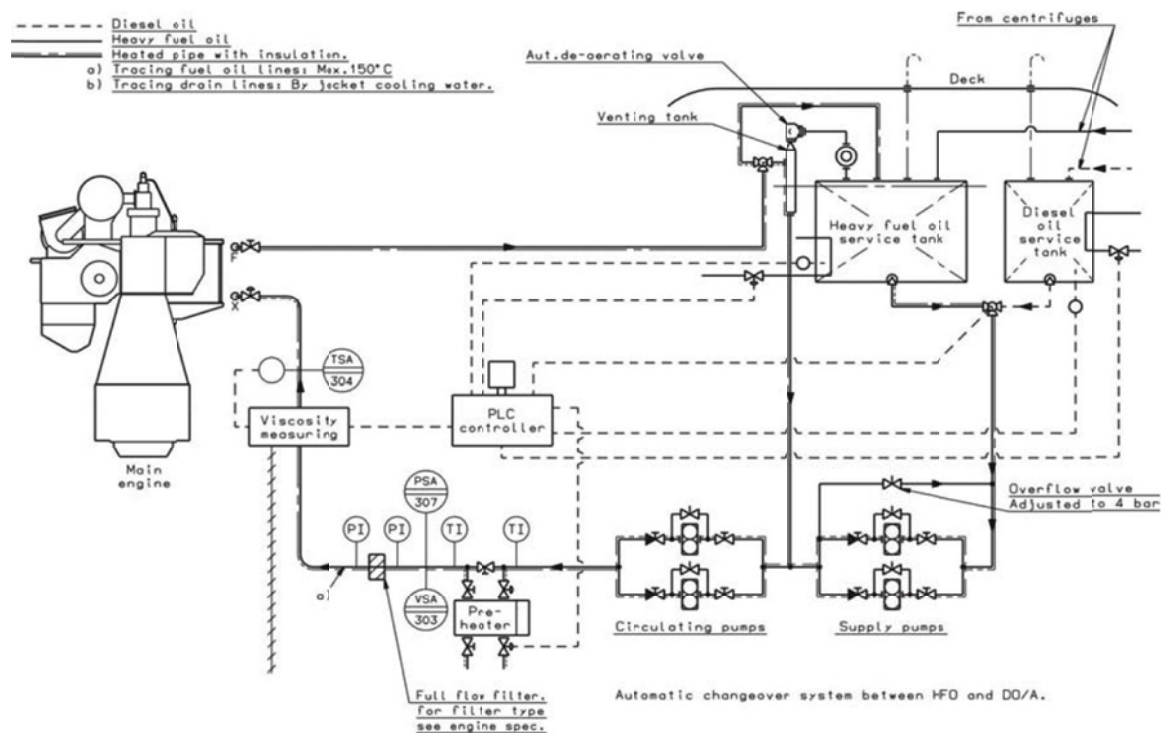
Figure 3.2-1: Example of Engine Fuel Flow Schematic Drawing.

Fuel viscosity can vary considerably depending on the fuel type and operating temperature. The fuel system for a modern diesel engine operating on heavy fuel oil has standard features to insure reliable engine operation. To accurately maintain the viscosity within a narrow range the fuel is continually being circulated (Figure 3.2-1). Modern systems are designed to handle fuel with viscosities as high as 700 centistokes (cSt) at 50° C.

A circulation system is necessary to insure proper operation of the diesel engine at all load conditions when burning HFO. Fuel viscosity must be maintained throughout the entire fuel injection system even when the main engine is stopped. Because HFO is very viscous, the fuel must be heated to about 100 to 120 degrees Celsius within the system fuel tanks and fuel lines to reduce the fuel's viscosity. The viscosity of heavy fuel oil is generally maintained between 13 and 17 cSt (see Table 3.2). If the heavy fuel oil becomes too viscous, the fuel may not pump properly.

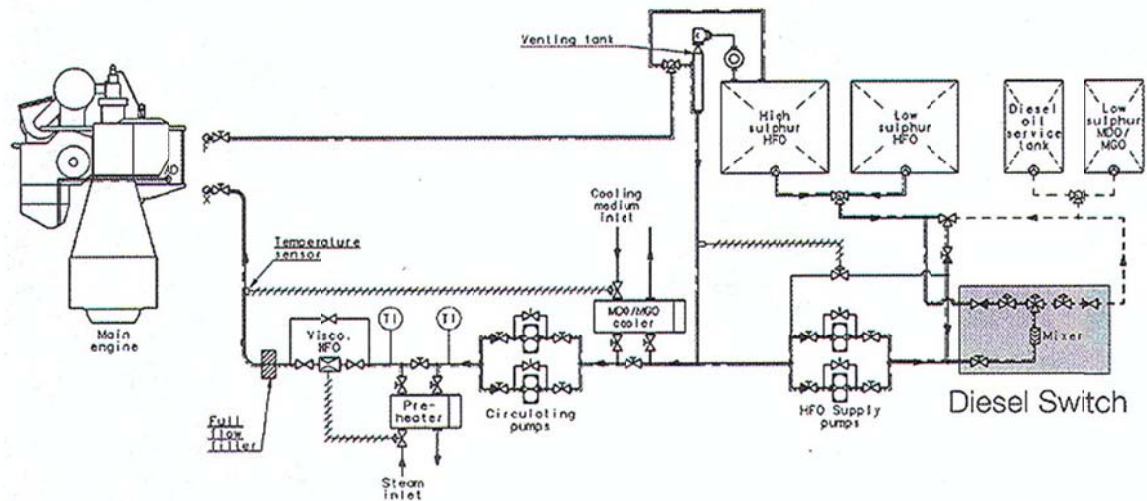
Figure 3.2-2: Modern Fuel System with A Distillate Fuel Cooler and Diesel Switch Modifications

During the switching process, a mixture of fuels with significantly different properties is circulated within the fuel system. For example, if the system was charged with distillate fuel and changing over to HFO was desired, the fuel temperature would be increased at a steady rate while HFO was slowly introduced into the fuel circulating system through a mixing valve. Throughout the process the appropriate fuel viscosity must be maintained while raising the fuel temperature at the prescribed rate. Automation is available which can simplify the switching process for the engineering crew and avoid rapid temperature deviations. One example would be the "Diesel Switch" sold by MAN B&W and is illustrated in Figure 3.2-2.

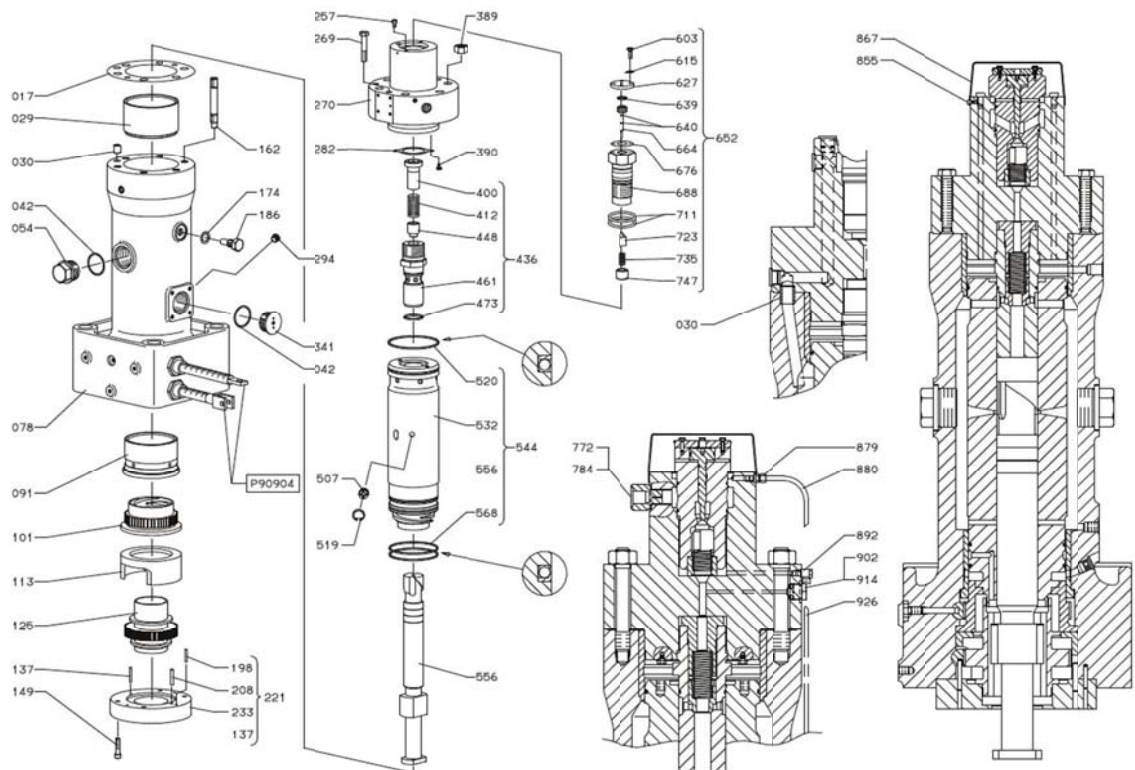
Figure 3.3-2: High Pressure Fuel Pump Assembly Drawings

The high pressure fuel pump system for a typical main engine is shown schematically in Figure 3.3-1 and as an assembly drawing is shown in Figure 3.3-2. This component has been associated with issues concerning leakage past the suction valve and internal O-rings. High pressure fuel pump leakage can occur due to, 1) worn barrel and plunger (piece 556 & 532), 2) leaking puncture valve slide (piece 723) or valve housing “O-ring” seals (piece 711), or 3) Leaking suction valve slide (piece 448) or seal (piece 473.)

The suction valve slide automatically lifts off its sealing surface allowing fluid from the pump suction gallery to enter the pump barrel on the downward stroke of the pump plunger. Any leakage of the housing seals or slide will lower the developed

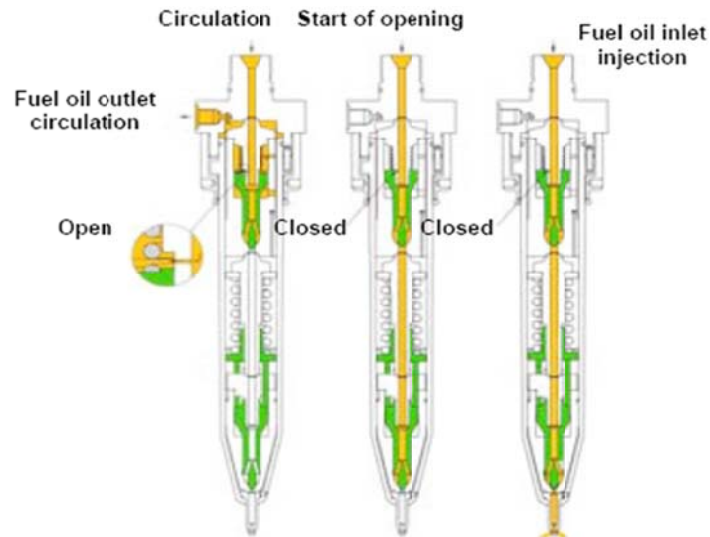
Figure 3.3-3: Example of Fuel Injector Circulation Diagram

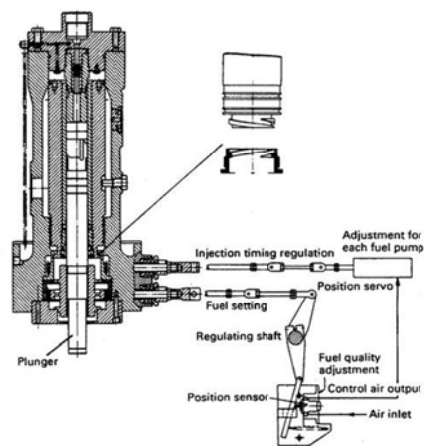
Figure 3.4-1: Super VIT System

Figure 3.4-1 depicts a common control arrangement used by MAN B&W on the slow-speed diesel engines. In this arrangement the pump barrel can be mechanically raised or lowered to advance or retard injection timing. The pump barrel has a threaded lower end which fits into the internal threads of the timing guide. The timing guide has a gear rim which meshes with a toothed rack that is linked to a servo-air cylinder. The position of the upper toothed rack determines the vertical position of the barrel relative to the plunger.

The VIT system must be checked regularly to insure that the system is moving freely and is operating in the manner prescribed by the engine manufacturer.
